N997CZ — GSU 25C ADAHRS Deviation Analysis & Replacement Verification

Original justification for service / replacement of the second ADAHRS (AHRS #2), prepared 2026-06-08, now updated 2026-06-13 with post-replacement verification data. From Garmin G3X flight-data logs.

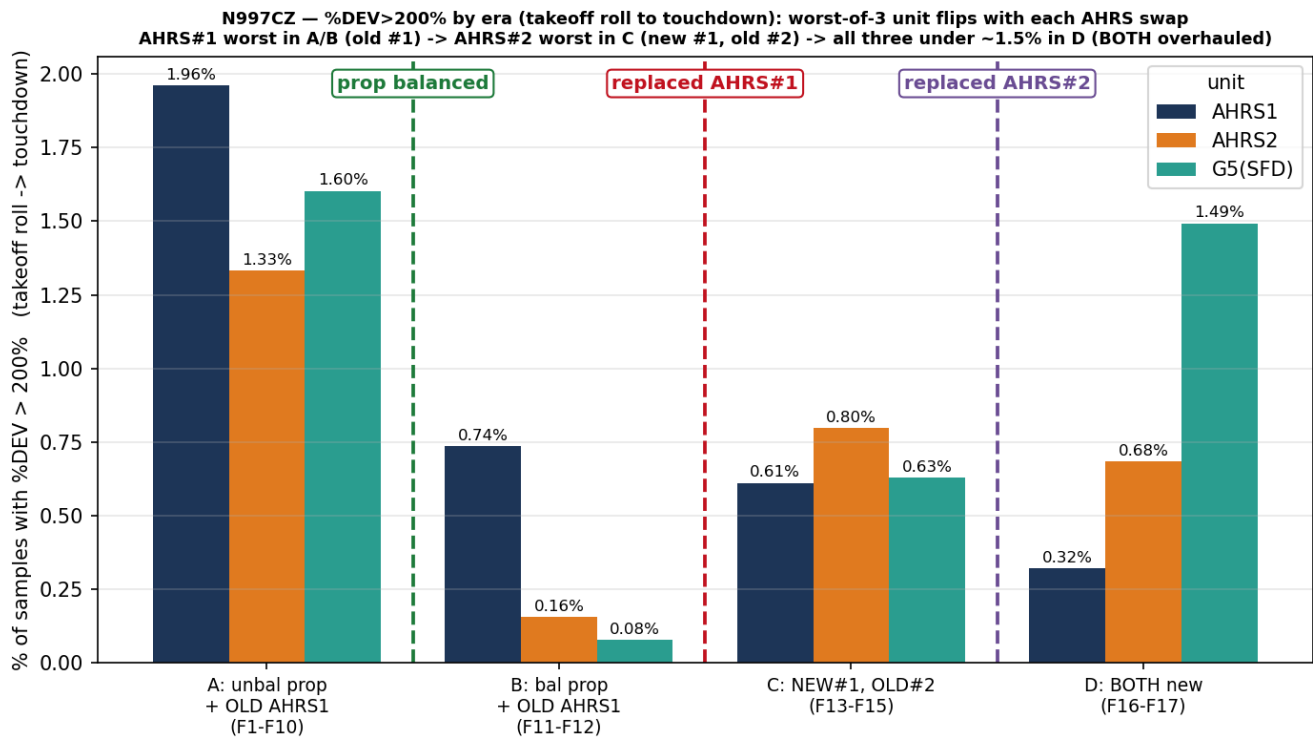
Chart 1 — ADAHRS deviation by era (reported %DEV > 200%, takeoff roll to touchdown)

- Considering only the larger excursions (reported deviation >200%), windowed from the start of the takeoff roll to touchdown and pooled by era: **AHRS #1 was the highest-deviation of the three sources on EVERY flight 5–12; after replacing AHRS #1, AHRS #2 is the highest-deviation source on EVERY flight 13, 14, 15.** The worst-performing unit flipped from #1 to #2 at the replacement (see Chart 1).

Each bar = the percentage of in-flight samples in which that unit reported deviation above 200%. Era A: original prop + original AHRS#1. Era B: after prop balance, still original AHRS#1. Era C: after the AHRS#1 replacement (AHRS#2 still original). Era D: after the AHRS#2 replacement (both units overhauled). The prop balance lowers all three units (A→B); after replacing AHRS#1 (B→C) **AHRS#2 becomes the highest-deviation unit**; after replacing AHRS#2 (C→D) **all three sources sit under ~1.5%**. (These two low-maneuvering flights make this maneuvering-sensitive metric less discriminating than the re-align and miscompare results above.)

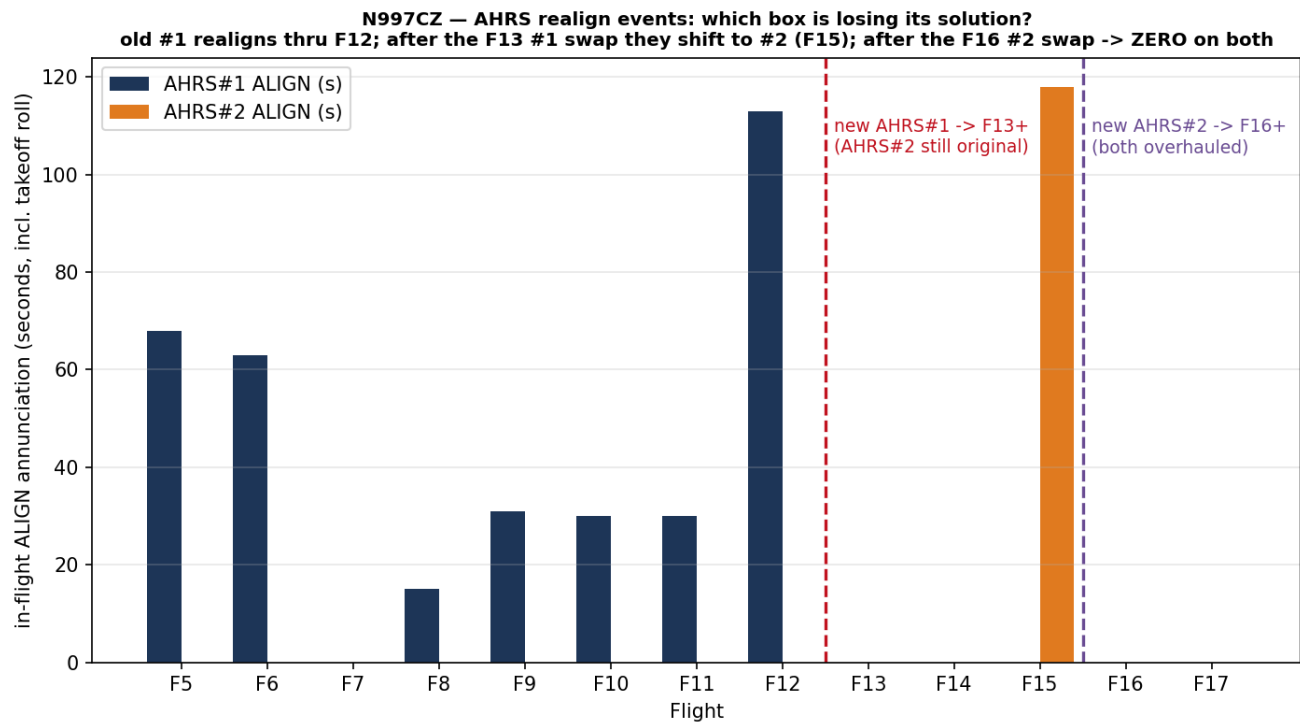
Chart 2 — In-flight ADAHRS re-align ("ALIGN") events per flight

- AHRS #2 re-align ("AHRS2 ALIGN") events, which had **never** appeared in flight on the old configuration, appeared on flight 15 (**118 s**), with the system annunciating "USING AHRS1" (reverting to the new AHRS #1) for 120 s (see Chart 2).

Seconds per flight that each unit annunciated an in-flight re-align (loss/reacquisition of its attitude solution), including the takeoff roll. **AHRs#1 (navy) re-aligned on flights 5–12 and stopped completely once the overhauled unit was installed at flight 13. On flight 15 the re-align appears instead on AHRs#2 (orange). After the AHRs#2 overhaul was installed (flight 16+), re-aligns go to zero on BOTH units — the verification result.**
