N997CZ — GSU 25C ADAHRS Deviation Analysis

Supporting data for service / replacement of the second ADAHRS (AHRS #2). Prepared 2026-06-08 from Garmin G3X flight-data logs.

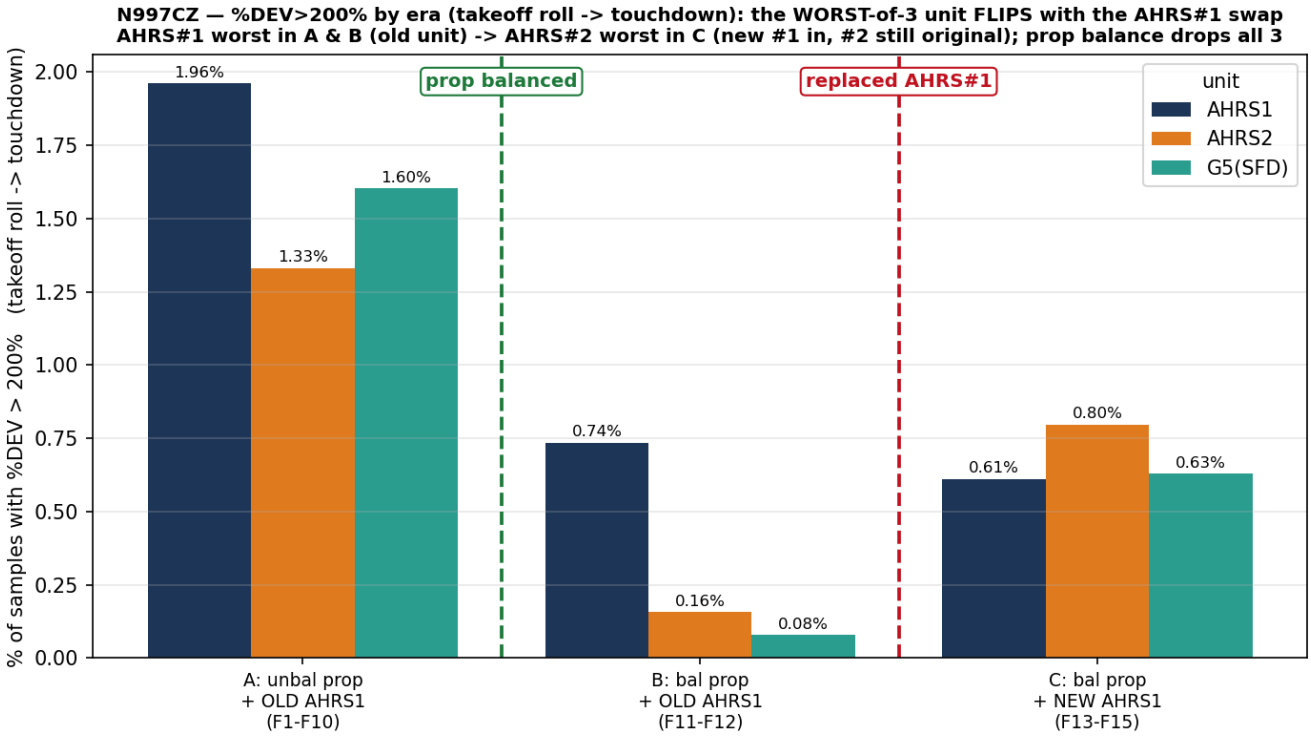
Chart 1 — ADAHRS deviation by era (reported %DEV > 200%, takeoff roll to touchdown)

- Considering only the larger excursions (reported deviation >200%), windowed from the start of the takeoff roll to touchdown and pooled by era: **AHRS #1 was the highest-deviation of the three sources on EVERY flight 5–12; after replacing AHRS #1, AHRS #2 is the highest-deviation source on EVERY flight 13, 14, 15.** The worst-performing unit flipped from #1 to #2 at the replacement (see Chart 1).

Each bar = the percentage of in-flight samples in which that unit reported deviation above 200%. Era A: original prop + original AHRS#1. Era B: after prop balance, still original AHRS#1. Era C: after AHRS#1 replacement. The prop balance lowers all three units (A→B); after replacing AHRS#1 (B→C) AHRS#1 is no longer the outlier and **AHRS#2 becomes the highest-deviation unit**. Per-flight, AHRS#1 was highest on every flight 5–12 and AHRS#2 is highest on every flight 13–15.

AHRS #2 now exhibits the same in-flight deviation and re-align signature that AHRS #1 exhibited before it was serviced, and it is now the worst-performing of the three attitude sources. Critically, the AHRS #2 re-align is **reproducible on command** (high angle-of-attack climbs), so the fault can be demonstrated repeatably on request. The overhaul of AHRS #1 clearly resolved that unit. **We respectfully request the same service / replacement for AHRS #2 (GSU 25C).**

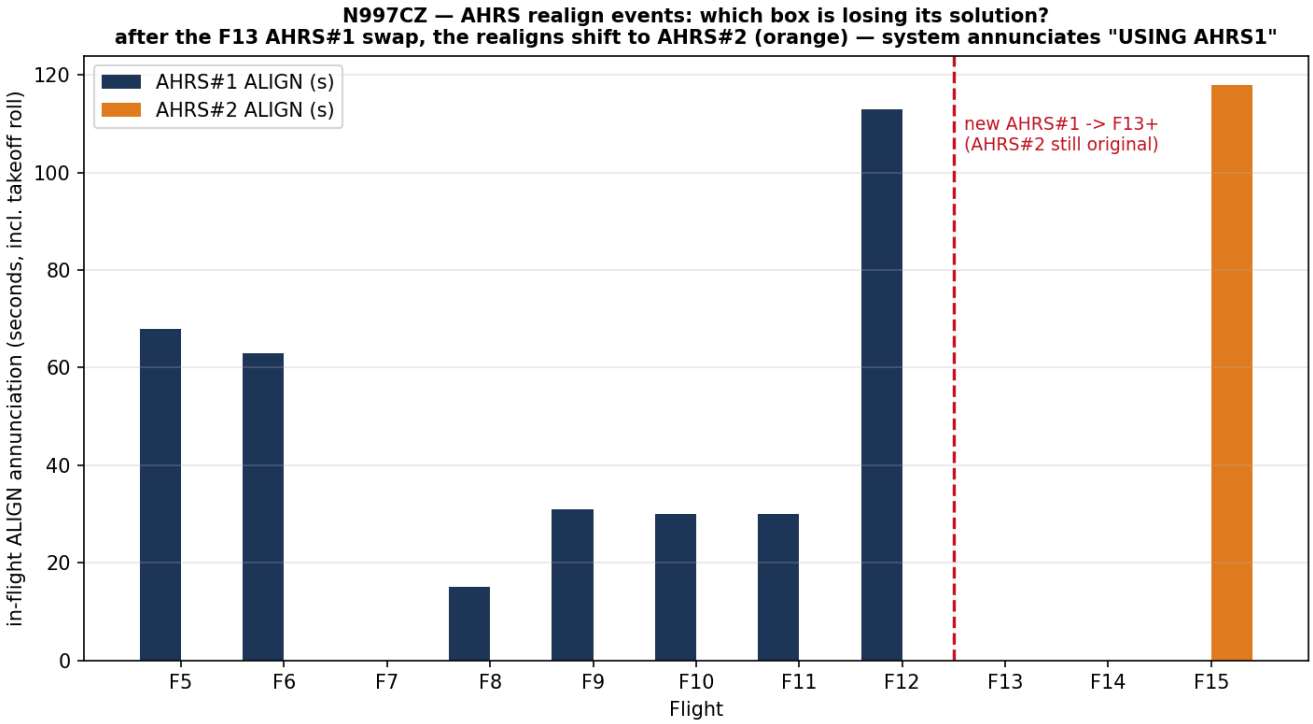
Chart 2 — In-flight ADAHRS re-align ("ALIGN") events per flight

- AHRS #2 re-align ("AHRS2 ALIGN") events, which had **never** appeared in flight on the old configuration, appeared on flight 15 (**118 s**), with the system annunciating "USING AHRS1" (reverting to the new AHRS #1) for 120 s (see Chart 2).

- **The AHRS #2 re-align is REPRODUCIBLE ON DEMAND:** it can be induced repeatedly by flying high angle-of-attack (slow, full-power) climbs. On flight 15 it recurred in ~8 separate events, all during the slow climbs (median ~89 KIAS, full power, nose-up) within a single 30-minute window — the fault can be triggered again at will for any diagnostic Garmin would like.

Seconds per flight that each unit annunciated an in-flight re-align (loss/reacquisition of its attitude solution), including the takeoff roll. **AHRS#1 (navy) re-aligned on flights 5–12 and stopped completely once the overhauled unit was installed at flight 13. On flight 15 the re-align appears instead on AHRS#2 (orange)**, with the system reverting to the new AHRS#1.
